National Aeronautics and Space Administration

# **Nuclear Compton Telescope Balloon Launch in Alice Springs, Northern Territory, Australia High Visibility Type B Mishap IRIS Case Number S–2010–119–00007 Volume I of II**

**Date of Mishap: April 29, 2010**

**Date of Report: September 7, 2010**

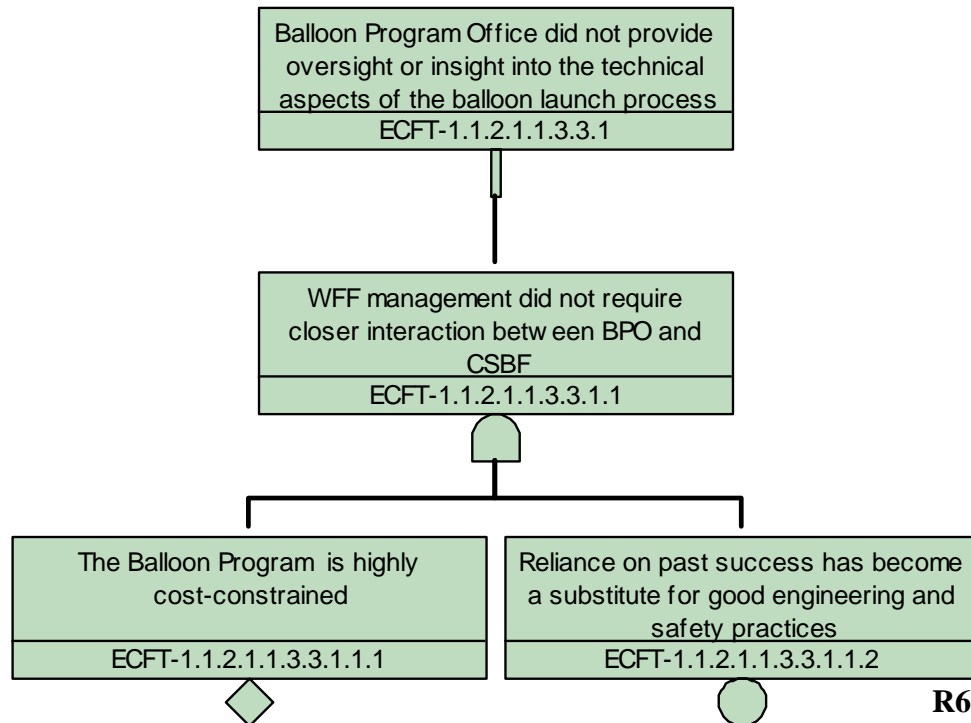
**Figure 60. Balloon Program Office Did Not Provide Oversight or Insight Into the Technical Aspects of the Balloon Launch Process**

- A. WFF management did not require close interaction between BPO and CSBF. This is evident from interviews.
1. The Balloon Program is highly cost-constrained. Interviews have indicated the perception that too much burden on the balloon program with additional requirements “will kill the balloon program.”
  2. Reliance on past success has become a substitute for good engineering and safety practices. Interviews have indicated a consistent theme that the balloon program success rate has been sufficiently high, so therefore there have not been problems to correct or additional scrutiny required. **Root Cause R6.**

- a. CSBF relied on real-time judgment rather than written procedures. The general approach has been to train the launch crew in a general sense and have them respond to the events with good judgment. This is evident from documentation and interview. The rest of this branch follows with the logic in Figure 60.
- b. CSBF relied on “on-the-job training” rather than written procedures. On-the-job training is used in place of explicit rules and procedures. This is evident from documentation and interview. The rest of this branch follows with the logic in Figure 60.
- c. CSBF has not analyzed the system to establish the acceptable range for launch. There is no evidence that anything but training and visual determination is used to decide when launch can take place. The rest of this branch leads to the same cause as determined from Figure 60.

- A. Training did not provide sufficient guidance to deal with all credible situations during launch. Interviews indicated that there is no specific training element to deal with anomalies or unexpected occurrences. The rest of the branch follows Figure 60.

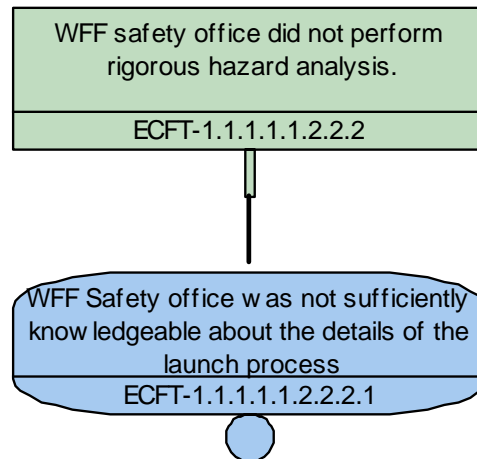
**Figure 61. WFF Safety Office Did Not Perform Rigorous Hazard Analysis**

- A. WFF Safety Office was not sufficiently knowledgeable about the details of the launch process. Interviews and documentation indicate that there is no one in the office cognizant of the details of the operations or hazards involved in launching balloons. **Root Cause R3.**

1. CSBF did not recognize launch operations as a hazardous procedure. Generally, the hazards were identified within the unique payloads, in the pyrotechnics, and in over flight. The rest of the logic flows as in Figure 61, as the lack of a full hazard analysis by the WFF safety office (as required in RSM 2002 Rev B, where WFF safety office is responsible for writing the ground safety plan) allowed this key hazard to slip through the cracks. This is indicated by documentation, in particular within the Ground Safety Plan.

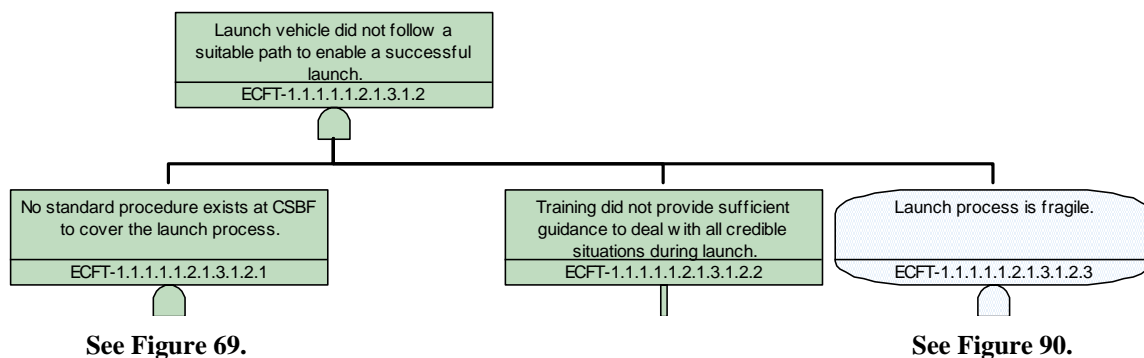
**Figure 62. Launch Vehicle Did Not Follow a Suitable Path to Enable a Successful Launch**

- A. No standard procedure exists at CSBF to cover the launch process. After reviewing all of the procedural documentation, no prescribed process was found for launching the balloon and there was minimal information provided in the documentation for on-the-job training.
- B. Training did not provide sufficient guidance to deal with all credible situations during launch. Interviews indicated that no specific training is provided to deal with anomalies or failed launch attempts. After this point, the logic follows the path shown in Figure 60 and will not be repeated in the report.
- C. Launch process is fragile. Without clear definition and procedures for dealing with anomalies, the launch process is highly sensitive to human error and general awareness as well as environmental conditions, such as terrain and weather. This is evident from interviews and documentation review.

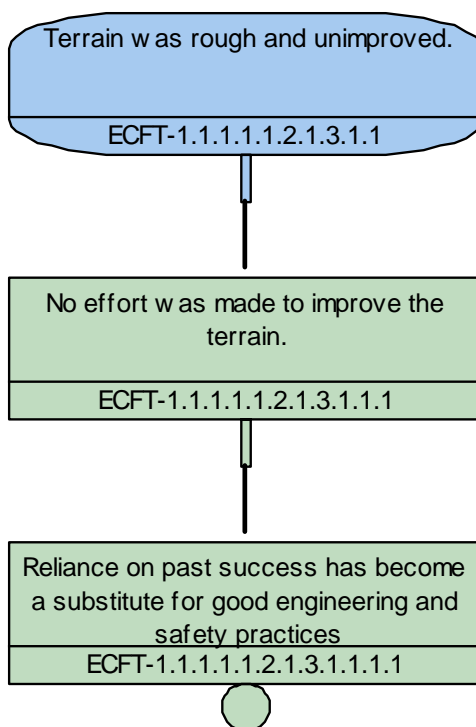
**Figure 63. The Terrain Was Rough and Unimproved**

- A. No effort was made to improve the terrain. Interviews indicate that requests were made to improve the terrain but that the requests never made it to NASA officials.
1. Reliance on past success has become a substitute for good engineering and safety practices. **Root Cause R6.**

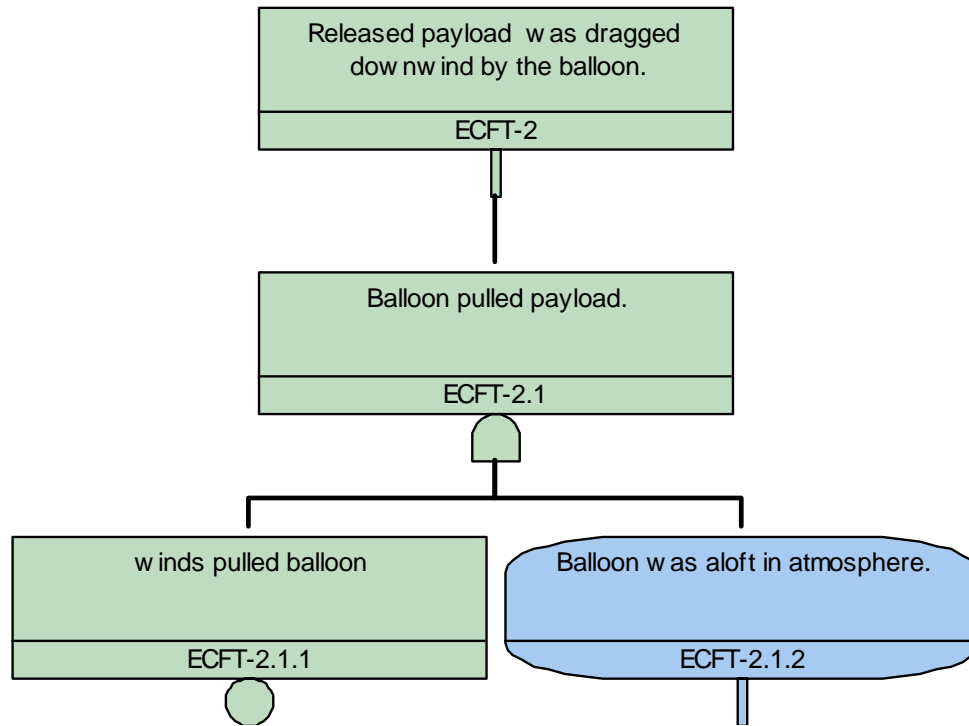
**Figure 64. The Released Payload Was Dragged Downwind by the Balloon**

Video evidence indicates that the payload, having been separated from the launch vehicle after the events described in Figure 54, was dragged along the ground, pulled by the balloon under and in the direction of the prevailing wind.

- A. The balloon pulled the payload, as indicated by video evidence.
  - 1. Winds pulled the balloon, as indicated by video evidence as well.
  - 2. The balloon was aloft in the atmosphere. Filled with helium, the balloon continued its motion with the prevailing winds, as indicated by video evidence.

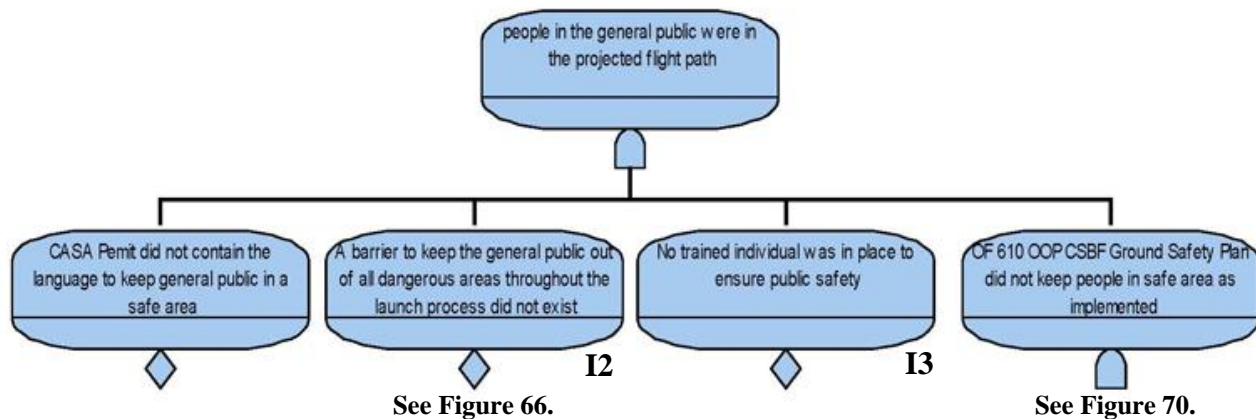
**Figure 65. The General Public Was in the Projected Flight Path**

An unusual situation occurred in the Balloon mishap at Alice Springs in which people of the general public, namely spectators, were in the projected flight path. The conditions leading to this were in essence a collection of failed or missing (but perhaps expected or perceived) barriers and controls, described as follows. This situation is indicated by video and photographic evidence, and interviews.

- B. There was no barrier in place to keep the general public out of all dangerous areas throughout the launch process. There was free access to a broad area downwind of the balloon to spectators and passers-by on public roads. There was a fence that kept unauthorized personnel out of an area downwind of the balloon but it still allowed people to be present within a hazardous area. This is indicated by video evidence, documentation, interview, and on-site assessment.

- D. The Balloon Ground Safety Plan did not keep people in a safe area as implemented as evidenced by video, documentation, and interview. The ground safety plan identified a set of hazards, but did not identify the actual hazard that was involved in this mishap--that of a heavy payload with high potential and mechanical energy. The plan defined a hazard zone, but it was not clear whether the zone was fixed or moving. There were no markings for the zone; the crew identified the boundaries by landmarks in the terrain. There was nothing to prevent the launch vehicle or targets from breaching the zone and nothing to indicate when the zone would be breached. If the zone were moving, there would be no practical way to use it as a barrier. If the zone were fixed, the size wasn't sufficient to cover the actual hazard area.

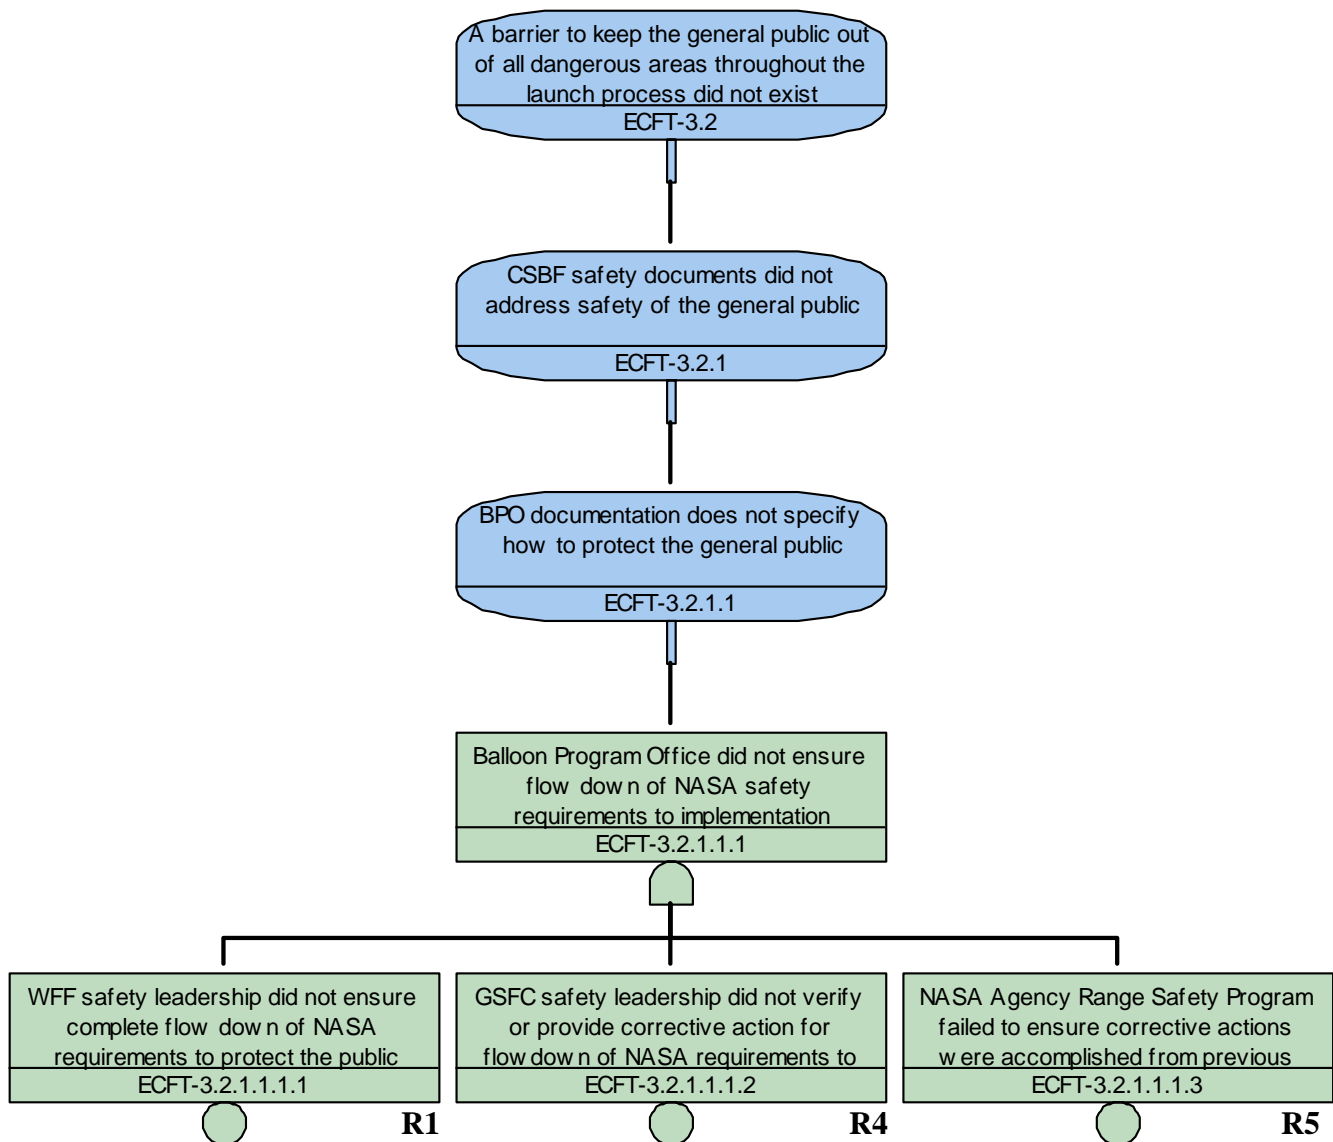
**Figure 66. A Barrier to Keep the General Public Out of All Dangerous Areas Throughout the Launch Process Did Not Exist**

- A. Neither CSBF nor Balloon Program Office safety documents address safety of the general public. Safety documentation of CSBF and the BPO lacks any provision for dealing with spectators and passers-by during the launch process.
1. BPO did not ensure flow down of NASA safety requirements to implementation. From RSM 2002 Rev B, BPO was delegated the responsibility to ensure safety requirements were implemented at the launch site, but lacking provisions for dealing with people appearing at the launch site indicates a failure to protect the general public due to the hazards associated with the launch process and the ability for people to gain proximity to the launch. This lack of adequate assurance of public safety amidst credible hazards contradicts the requirements in several NASA safety documents, to include NPR 8715.3 and NPR 8715.5.

- a. WFF safety leadership did not ensure complete flow down of NASA requirements to protect the public. While the BPO is delegated the responsibility for implementation of safety requirements in balloon activities, WFF safety leadership, to include at a minimum the WFF Safety Office and Code 800 management was not aware that public safety was endangered during balloon activities. Such awareness would have likely prevented the undesired outcome. **(Root Cause R1)**

- b. GSFC safety leadership did not verify or provide corrective action for flow down of requirements to protect the general public. GSFC safety leadership responsible for safety of activities conducted by WFF did not ensure that the appropriate safety practices were in place to protect the public in all such activities. **(Root Cause R4)**

- c. NASA Agency Range Safety Program failed to ensure corrective actions were accomplished from previous agency audits. Several items from a 2002 audit had not been closed, but in particular one item found that “Balloon Program payloads are potentially hazardous to the public and should be managed consistent with other hazardous, uninhabited programs” and this item was still not closed. A finding that activities endanger the public did not prompt diligent follow-up and elevation to the highest level of NASA to prevent such activities from continuing without proper mitigations. **(Root Cause R5)**

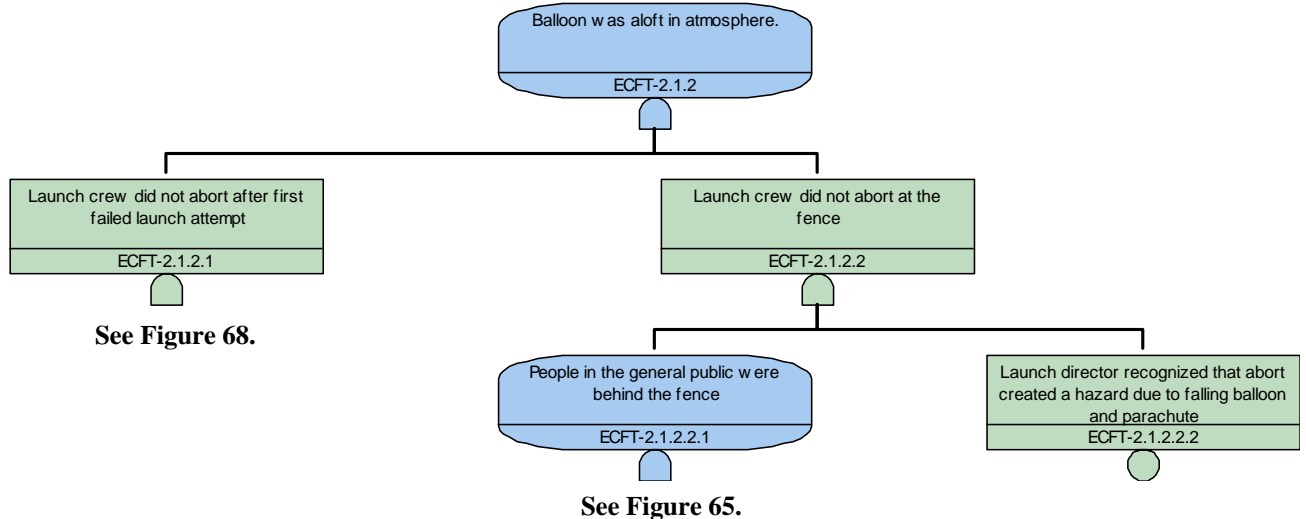
**Figure 67. Balloon Was Aloft in the Atmosphere**

- A. The launch crew did not abort after the first failed launch attempt. When the launch director was unable to get the pin to release from pulling on the lanyard, he decided to chase the balloon for another attempt. Had they aborted after the first attempt, the undesired outcome would not have occurred. This was evident from video evidence and interview.

- B. The launch crew did not abort at the fence. After the launch vehicle had breached any possible interpretation of the hazard zone, a physical limit was reached when it came to a fence. At this time, the launch director recognized that there was no further hope for a successful launch, but he did not abort the balloon. This was revealed from video evidence and interview.

1. People from the general public were located immediately behind the fence, as indicated in video evidence and interview. This leads to the same set of events in the branch shown in Figure 65.

2. The launch director recognized that abort created a hazard due to the falling balloon and parachute as indicated from interview and video evidence. This hazard was due to heavy components in the flight train, balloon, and the parachute and aborting would risk these components falling on anyone in the vicinity. Hence he realized that he needed to move to a different location to abort. However, had he remained in that position, if there were an individual with responsibility for protecting the public, the people could have been moved to a safe location in order to ensure a safe abort.

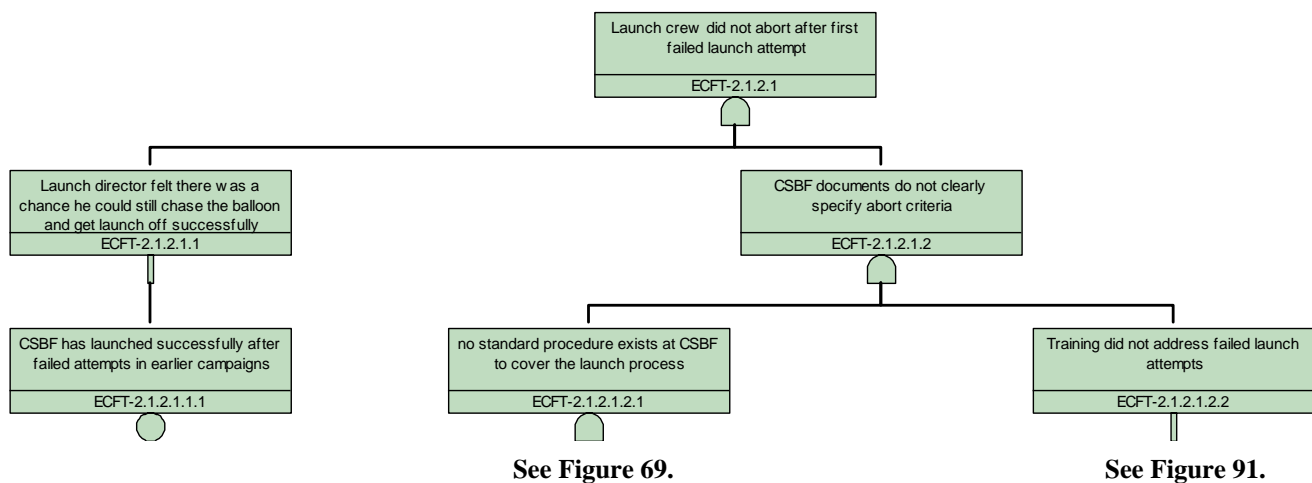
**Figure 68. Launch Crew Did Not Abort After the First Failed Launch Attempt**

- A. The launch director felt there was a chance he could still chase the balloon and get the launch off successfully. Hence, he proceeded forward to get into a better position under the balloon. In fact, had there been no fence or people around, evidence indicates that he eventually would have caught the balloon. This was evident from interview and video evidence.
1. CSBF has launched successfully after failed attempts in earlier campaigns. Hence there was no expectation that they wouldn't eventually get into a proper position to launch. This was indicated from interviews.
- B. CSBF documents do not clearly specify abort criteria. Abort is performed only as an instinctual action and not based on clear guidance.

1. Based on interview and documentation review, it became clear that no standard procedure exists at CSBF to cover the launch process. It is entirely reliant on human observation and decision-making.
2. Training did not address failed launch attempts. In general, launch directors are not given clear direction for the possible range of contingency and anomalous situations.

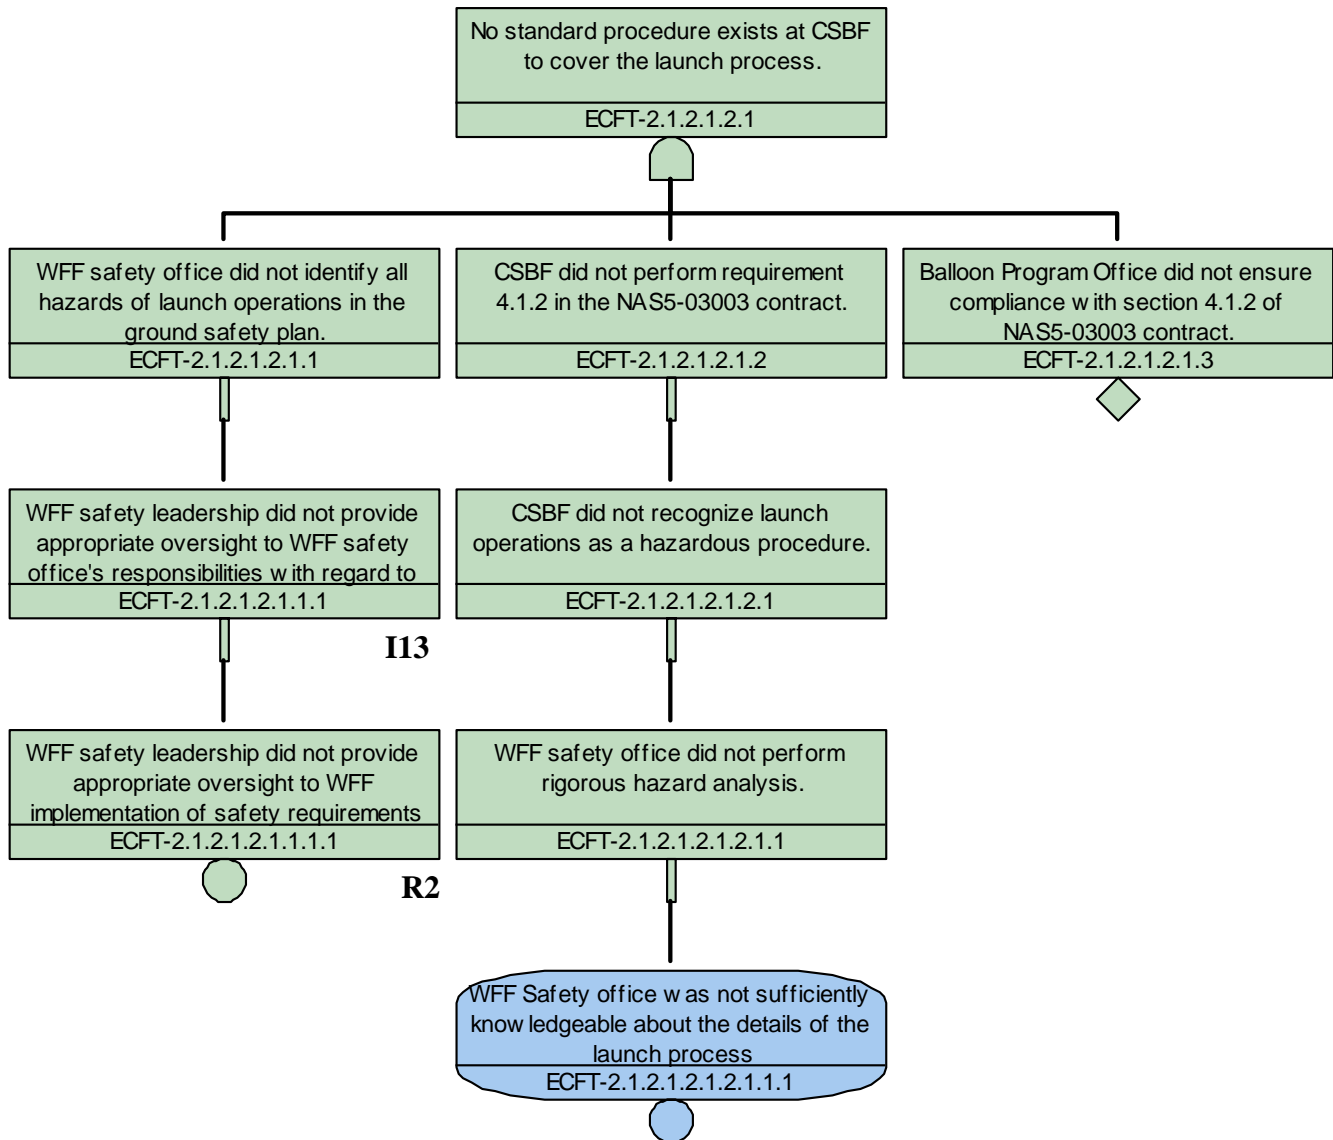
**Figure 69. No Standard Procedure Exists at CSBF to Cover the Launch Process**

- A. WFF safety office did not identify all hazards of launch operations in the ground safety plan. In particular, the energy in the hanging payload was not identified as a hazard. Nor were the hardware in the balloon or parachute identified as hazards, although they were identified as hazards by the launch director when the vehicle approached the fence. This was evident from

reviewing ground safety documentation, including the ground safety plan. Given that the hazards of launch operations were not identified, there was no recognition that a procedure would be required to cover the launch process.

1. WFF safety leadership did not provide appropriate oversight to WFF safety office's responsibilities with regard to the balloon program. WFF safety leadership did not pay particularly close attention to the broad set of safety practices within the balloon program, particularly anything outside of over flight casualty assessments. This is evident from interview, documentation, and video evidence. **Intermediate Cause I13**

- a. WFF safety leadership did not provide appropriate oversight to WFF implementation of safety requirements. **Root Cause R2.**
- B. CSBF did not perform requirement 4.1.2 in the NAS5-03003 contract, as evident from documentation and interviews. Requirement 4.1.2 states that written procedures are required for any hazardous procedure and given that the launch process involves many hazards, it requires written procedures.

- C. Balloon Program Office did not ensure compliance with section 4.1.2 of NAS5-03003 contract. BPO did not ensure that procedures were written to cover the launch process.

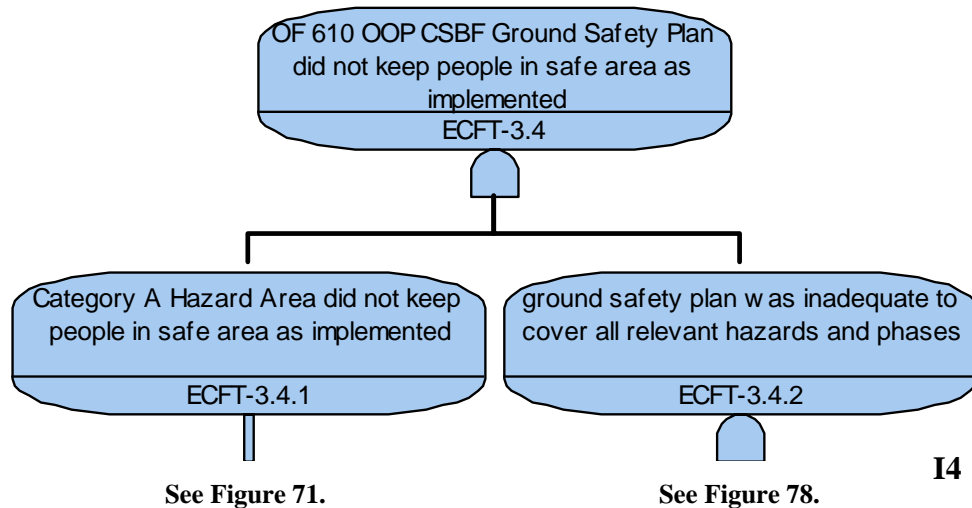
**Figure 70. The OF 610 CSBF Ground Safety Plan Did Not Keep People in a Safe Area as Implemented**

- A. The Category A Hazard Area did not keep people in a safe area as implemented. Although generally the launch crew was aware of a hazard area, known by several different names, it was ineffective at keeping people out of harm's way. This was evident from video evidence and interview.
- B. The ground safety plan was inadequate to cover all relevant hazards and phases according to documentation review. The plan did not cover the detailed actions generally performed in the launch phase and it failed to identify several hazards, including that of the stored energy in a hanging payload and the hardware present in the balloon and parachute that could land on people or property in the case of an abort. **Intermediate Cause I4**

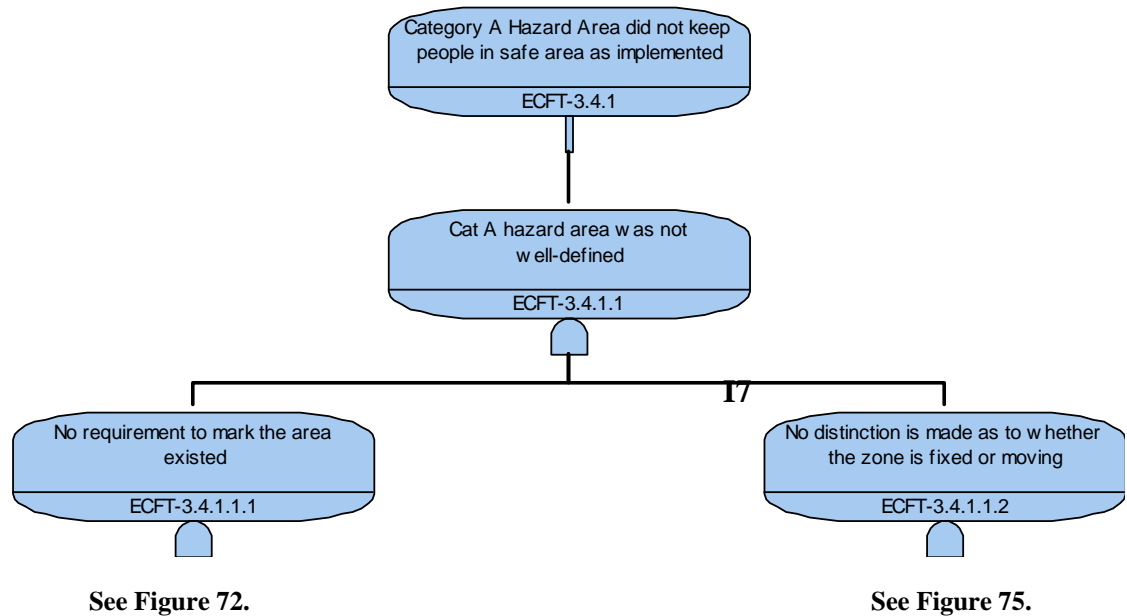
**Figure 71. The Category a Hazard Area Did Not Keep People in a Safe Area as Implemented**

- A. The Category A Hazard Area was not well-defined. There are several different interpretations of the area within the BPO and CSBF. This was evident from review of documentation.

1. No requirement to mark the area existed, based on review of documentation. Henceforth, there was no way for anyone to tell when it was close to being breached.
2. No distinction is made as to whether the zone is fixed or moving, as indicated from documentation. The definition of the zone would tend to lean towards it being a moving area, but a moving area would not be implementable. A fixed area would be insufficient to cover the most relevant hazards during launch. The BPO believes the zone to be moving while CSBF believes the zone to be fixed.

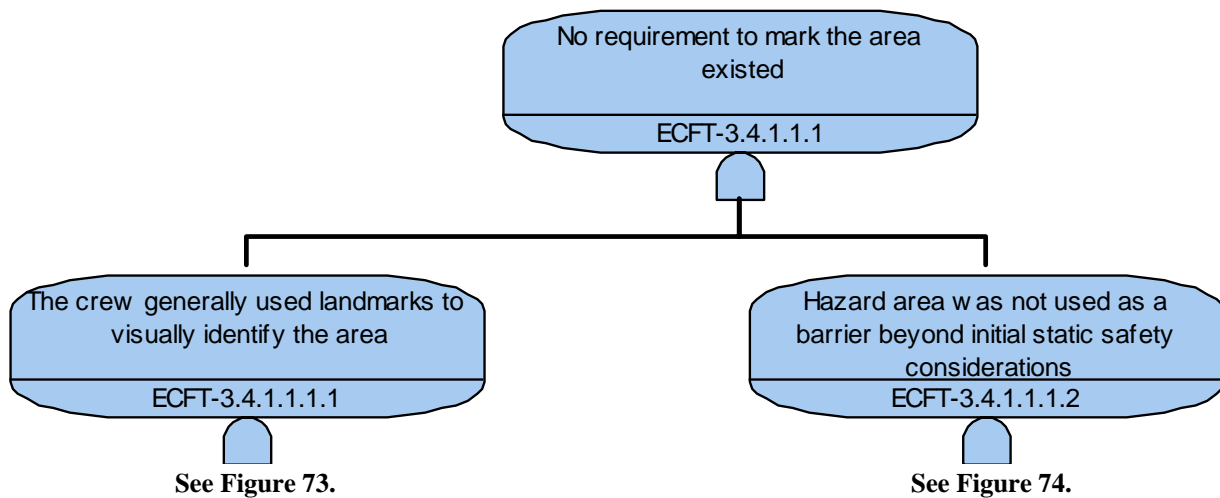
**Figure 72. No Requirement to Mark the Area Existed**

- A. The crew generally used landmarks to visually identify the area. Interviews indicate that during set up for launch the crew would loosely walk off the hazard area and take mental note of identifying features at the edges of the zone.
- B. The hazard area was not used as a barrier beyond initial static safety considerations. There is no evidence that there is any consideration of the Category A Hazard Area once the launch vehicle begins to move.

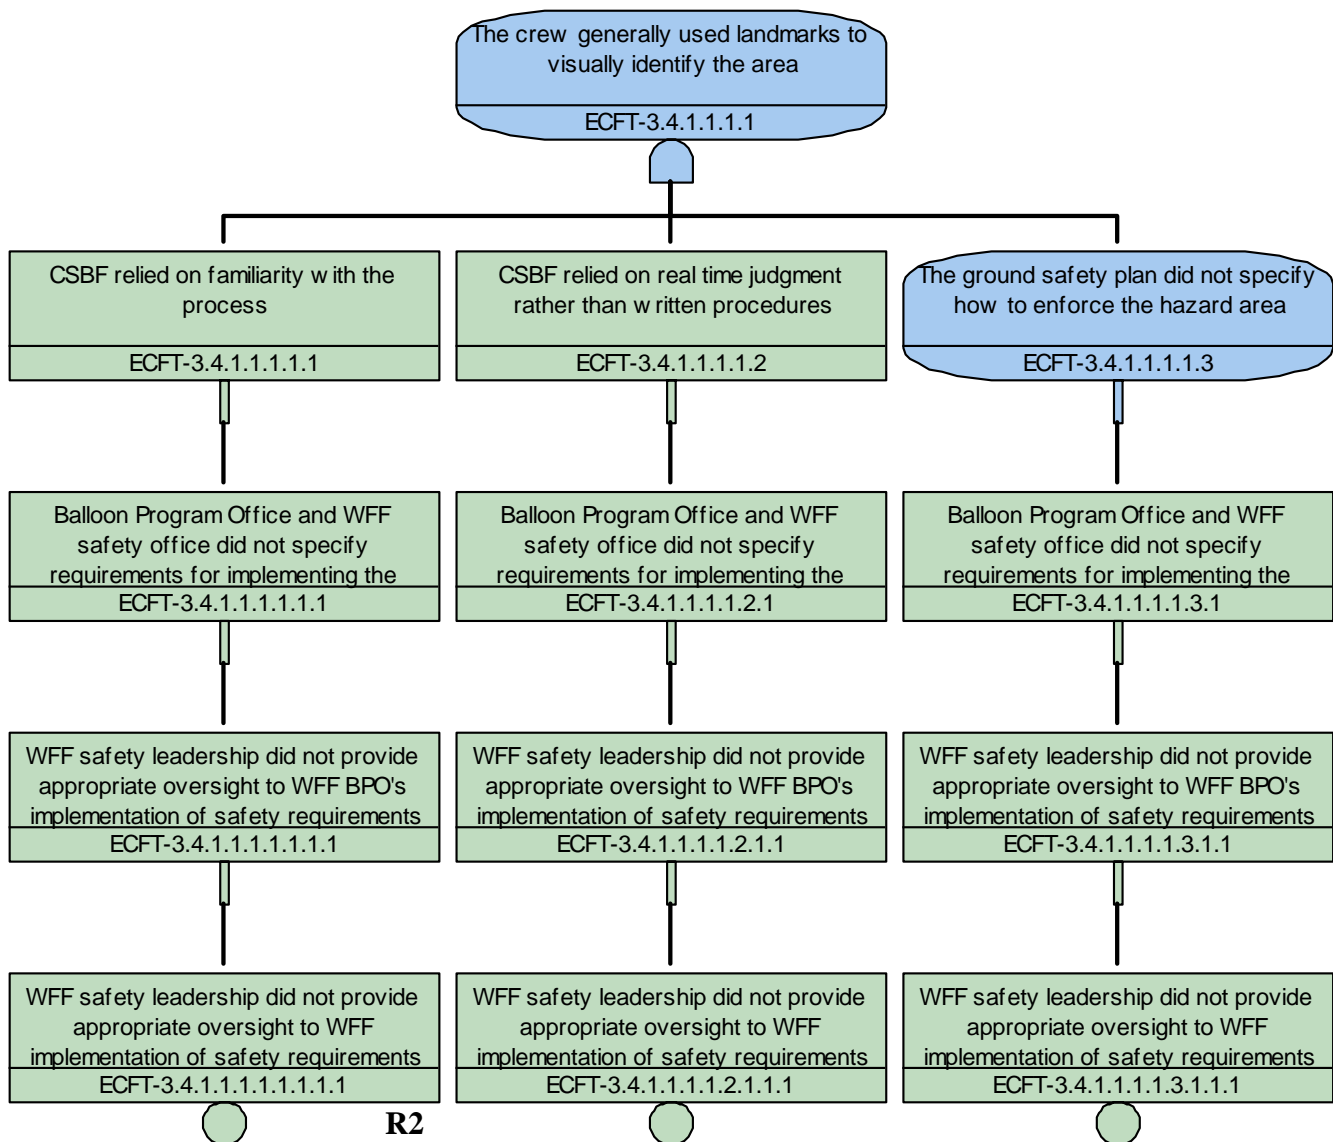
**Figure 73. The Crew Generally Used Landmarks to Visually Identify the Area**

- A. CSBF relied on familiarity with the process. Rather than explicitly marking things off and writing down procedures, CSBF based successful operations on experience and training, which left much susceptible to human error or lack of understanding of what to do in contingency or anomalous situations. This was evident from interviews and documentation.
1. BPO and WFF safety office did not specify requirements for implementing the hazard area. This responsibility was fully contractually delegated to the CSBF but given the safety implications, both should have been knowledgeable about how this was being performed. This was evident from interviews and documentation.
    - a. WFF safety leadership did not provide appropriate oversight to WFF BPO's implementation of safety requirements. Interviews indicate that the balloon program has

- i. WFF safety leadership did not provide appropriate oversight to WFF implementation of safety requirements. **Root Cause R2.**

- B. CSBF relied on real-time judgment rather than written procedures. This is based on documentation and interview and the logic flow is the same as that in item A. above.
- C. The ground safety plan did not specify how to enforce the hazard area. This is based on documentation and the logic flow is the same as that in item A. above.

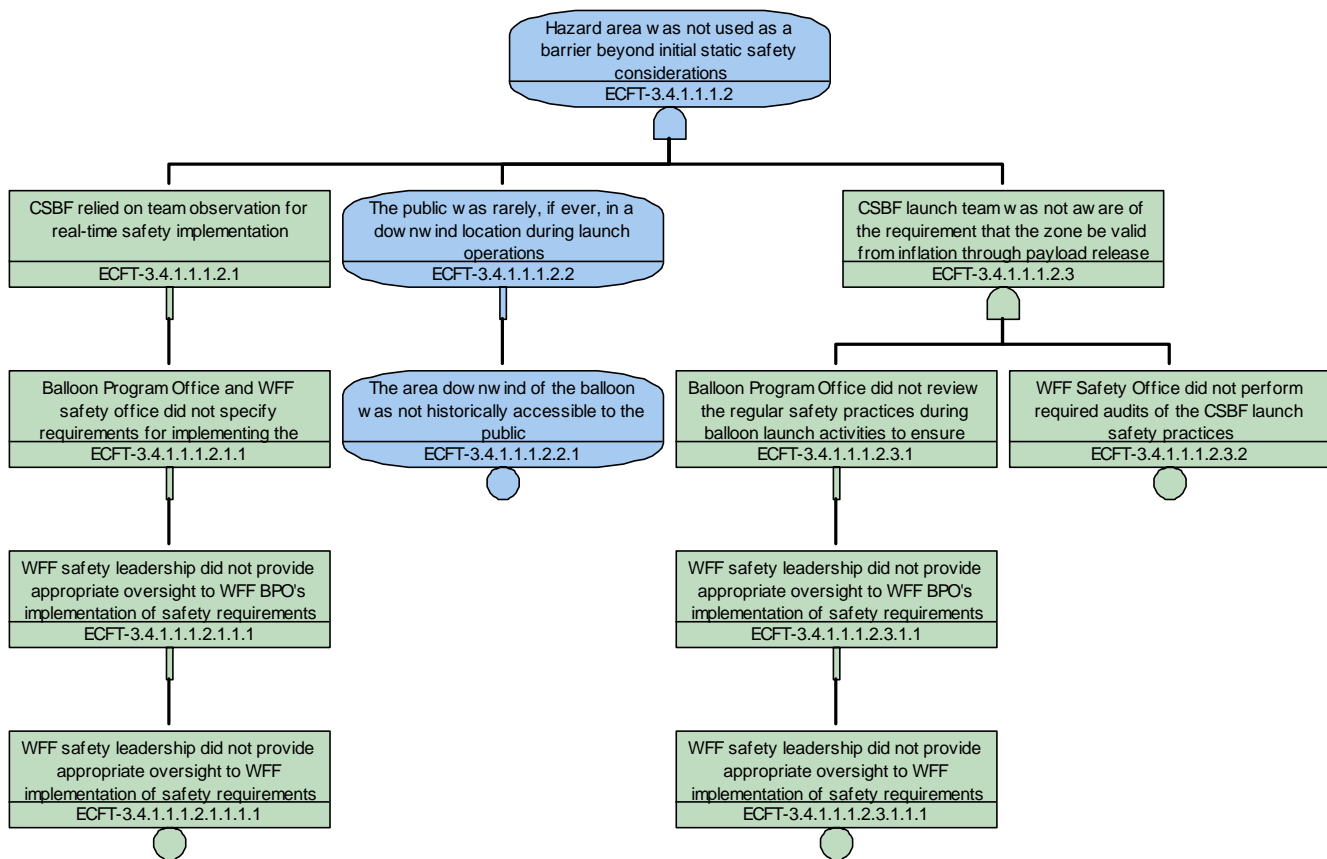
**Figure 74. The Hazard Area Was Not Used as a Barrier Beyond Initial Static Safety Considerations**

- A. CSBF relied on team observation for real-time safety implementation. There was no coordinated effort or centralized responsibility for safety and this mode leaves much to having problems slip through the cracks. This was evident from interviews and documentation.
  1. BPO and WFF Safety Office did not specify requirements for implementing the safety zone. Safety documentation written and approved by BPO and WFF defines the zone in general terms but does not indicate any requirements for implementation, as indicated in the Ground Safety Plan.

- a. WFF safety management did not provide appropriate oversight to WFF BPO's implementation of safety. The extent of oversight does not go beyond knowledge of the safety documentation, primarily the ground safety plan and the balloon risk analysis. This was evident from interviews. The logic flow continues as in Figure 73.

- a. WFF Safety leadership did not provide appropriate oversight to WFF BPO's implementation of safety. WFF BPO's implementation of the safety during balloon launches was "out-of-sight, out-of-mind" to WFF safety leadership. The logic flow continues as in Figure 73.

2. According to interviews, WFF Safety Office did not perform required audits of the CSBF launch safety practices. These audits were to be in response to the 2002 audit by NASA HQ OSMA. However, they were never performed.

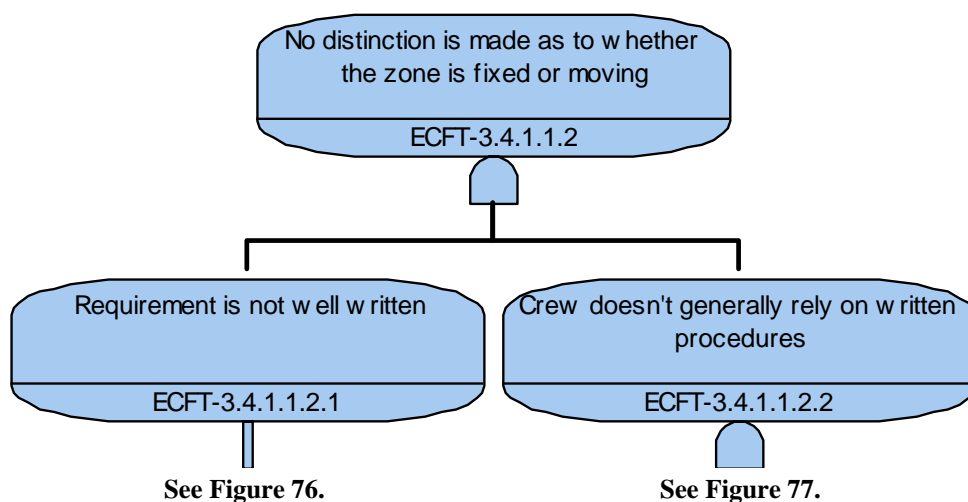
**Figure 75. No Distinction Is Made as to Whether the Zone Is Fixed or Moving**

- A. The requirement is not well-written. There is no specific discussion about what happens when the vehicle moves or how one would determine whether the zone is breached in practice. This is evident from review of the Ground Safety Plan.
- B. The crew doesn't generally rely on written procedures, according to documentation and interviews. Training and experience are the primary means to successfully launch balloons.

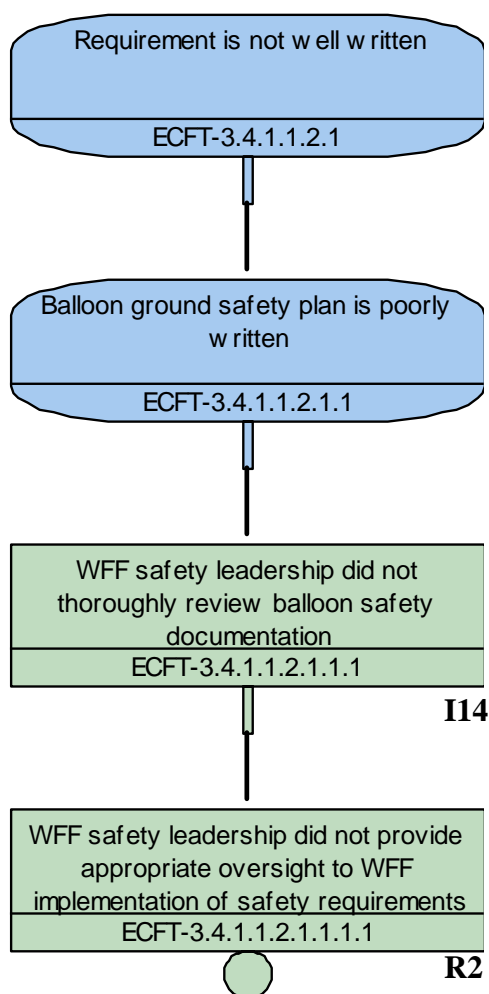
**Figure 76. Requirement Is Not Well Written**

- A. The balloon ground safety plan is poorly written. It leaves out many of the details during the launch process and does not address all hazards.
1. WFF safety leadership did not thoroughly review balloon safety documentation. There is much ambiguous language in the documentation, hazards are not covered completely, there is no provision to protect the public except in the over flight phase, and it does not completely cover all phases of balloon operations. **Intermediate Cause I14**
    - a. WFF safety leadership did not provide appropriate oversight to WFF implementation of safety requirements. **Root Cause R2.**

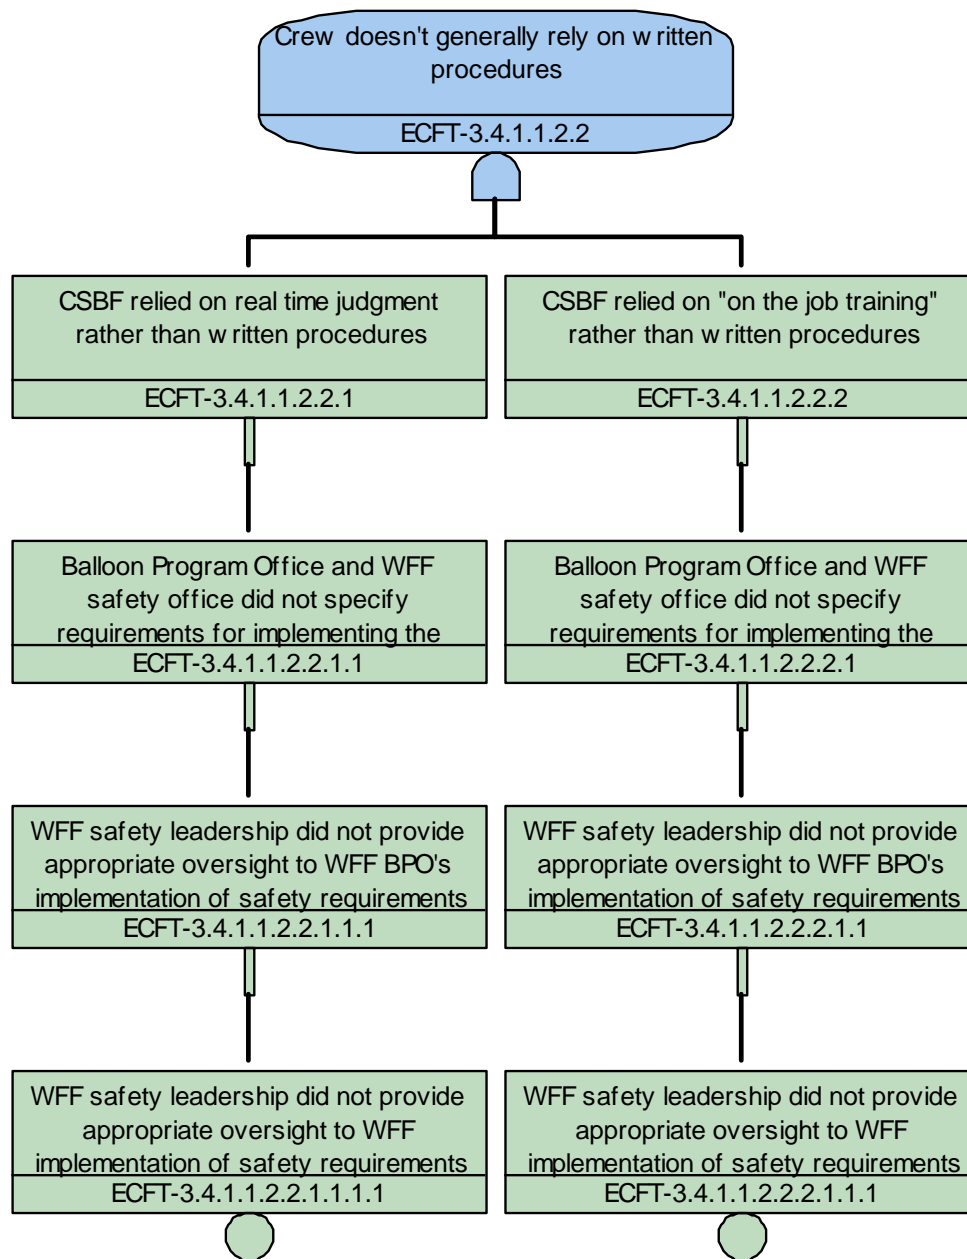
**Figure 77. Crew Does Not Generally Rely on Written Procedures**

Both of the following items lead through the same path as in branch “A” of Figure 74.

- A. CSBF relied on real-time judgment rather than written procedures. The general approach is to train the launch crew in a general sense and have them respond to the events with good judgment. This is according to interviews and documentation.
- B. CSBF relied on “on-the-job training” rather than written procedures. On-the-job training is used in place of explicit rules and procedures. This is according to interviews and documentation.

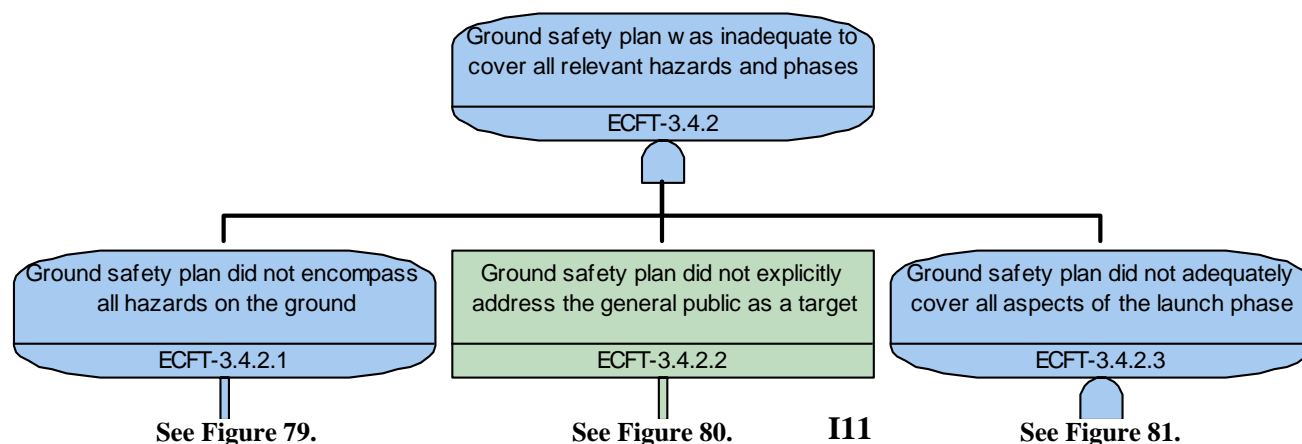
**Figure 78. The Ground Safety Plan Was Inadequate to Cover All Relevant Hazards and Phases**

- A. The ground safety plan did not encompass all hazards on the ground. For example, neither the hazard of a hanging heavy payload, nor those of the balloon or parachute and associated hardware falling due to an abort were acknowledged.
  - B. The ground safety plan did not explicitly address the general public as a target. The plan only focused on personnel and keeping unauthorized personnel out of a hazard zone, but did nothing to address hazards to spectators or passers-by. **Intermediate Cause I11**
  - C. The ground safety plan did not adequately cover all aspects of the launch phase. The process of moving the crane around to chase the balloon, attempting launch, and the process and requirements for abort are not thoroughly covered.
-

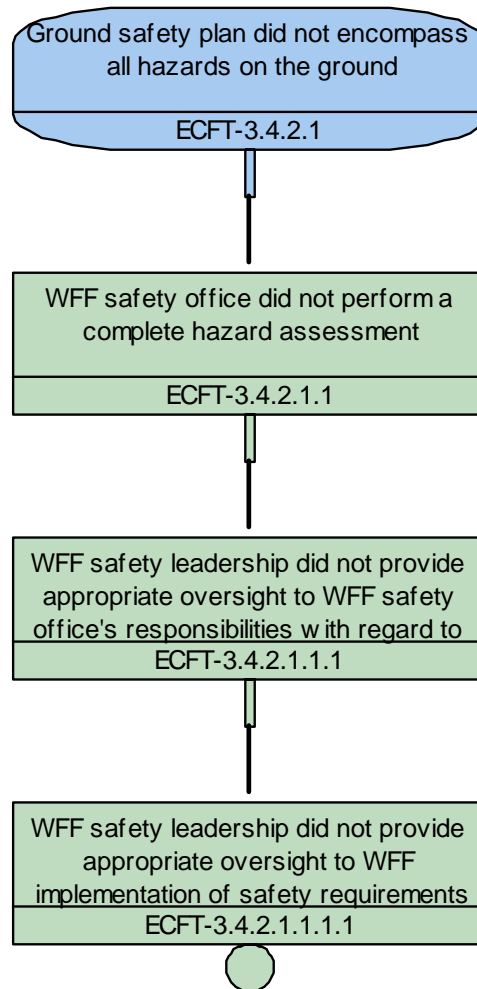
**Figure 79. The Ground Safety Plan Did Not Encompass All Hazards on the Ground**

- A. WFF Safety Office did not perform a complete hazard assessment. The WFF Safety Office is responsible, according to RSM 2002 Rev B, for developing the ground safety plan. This plan includes the only reference in the balloon safety documentation to hazards during ground operations. Only a subset of the actual hazards during ground operations is indicated and no full hazard analysis exists.
1. WFF safety leadership did not provide appropriate oversight to WFF Safety Office's responsibilities with regard to the balloon program. The safety leadership at WFF fully delegated responsibilities that had full bearing on safety of the public to the WFF Safety Office without any indication of audit or review of all aspects of safety. The remainder of the logic flow is as in several previously-described branches.

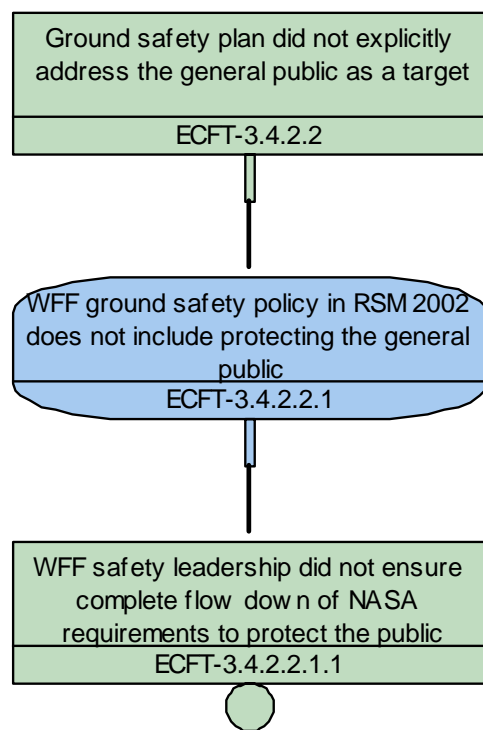
**Figure 80. The Ground Safety Plan Did Not Explicitly Address the General Public as a Target**

- A. WFF ground safety policy in RSM 2002 (Rev B) does not include protecting the general public. Dangers to the general public during ground operations were not understood or acknowledged.
  - 1. WFF safety leadership did not ensure complete flow down of NASA requirements to protect the public. RSM 2002 does not account for hazards to the general public during ground operations and protection of the public is not addressed in the CSBF documentation.
